Ghour Al- Safi Grading Facility

Description of Design and Rehabilitation Work

25/07/2010

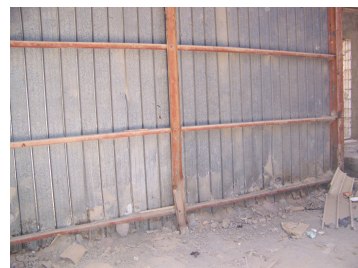
However; the smashed side walls members and panels are not considered as main structural elements and do not affect the structural soundness of the hanger.

Main problems identified in the structural design consist of a number of structural elements and panels that are smashed or dent

- Dismantle the smashed elements, maintain, re-paint and re-install.
- Install new elements due to the reason that maintenance cost may be equal or more than the costs of new elements.
- Fix new equivalent member adjacent to the existing smashed elements in order to bear its loads

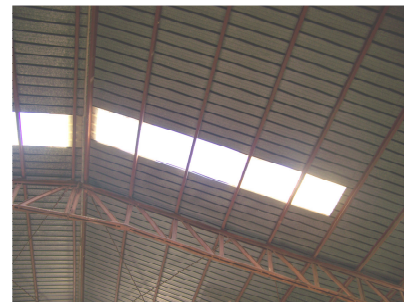
The translucent panels available in the hanger are in bad condition.

Due to the need to minimize repair cost, the proposal was to dismantle the translucent panels, maintain, change the transperance panel, re-paint and re-install.

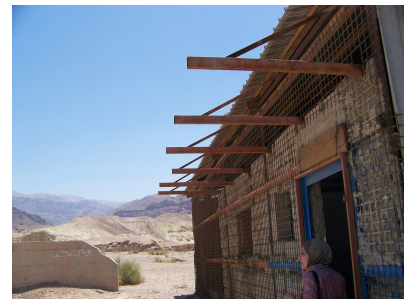
Block walls available in the hanger are in bad condition.

It was proposed to replace the broken blocks, plaster and paint them.

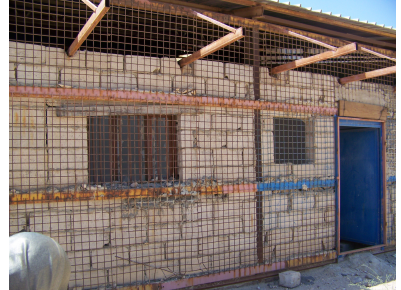
Windows and doors within the block wall available in the hanger are in bad conditions; in addition, new doors and windows were needed and proposed in response to the new architectural design of the new facilities within the Hanger.

New windows and doors were proposed for the reason explained above and because maintaining existing windows and doors cost maybe around or more than cost of new windows and doors
